A. Pavement Management Plan

A. Airfield Pavement Management Study

McFarland-Johnson, Inc. (Engineer/Consultant) was retained by the Counties of Luzerne and Lackawanna, Pennsylvania, Owner/Sponsor of the Wilkes-Barre/Scranton International Airport (AVP) to provide planning and engineering services to complete a Master Plan Update (MPU) and Airport Layout Plan Update (ALPU).

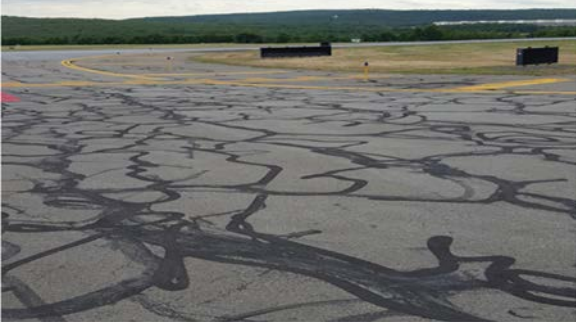
Figure A-3: Visual Representation of PCI Values

The PCI represents the overall condition of the pavement ranging from 100. A pavement section in excellent condition receives a PCI of 100, with a failed pavement section receiving a PCI score of zero. **Figure A-3** shows a visual representation of several PCI values at AVP.

Pavement Surface ¹	PCI
 	84
 	63

41
