A5. Inspection Photographs

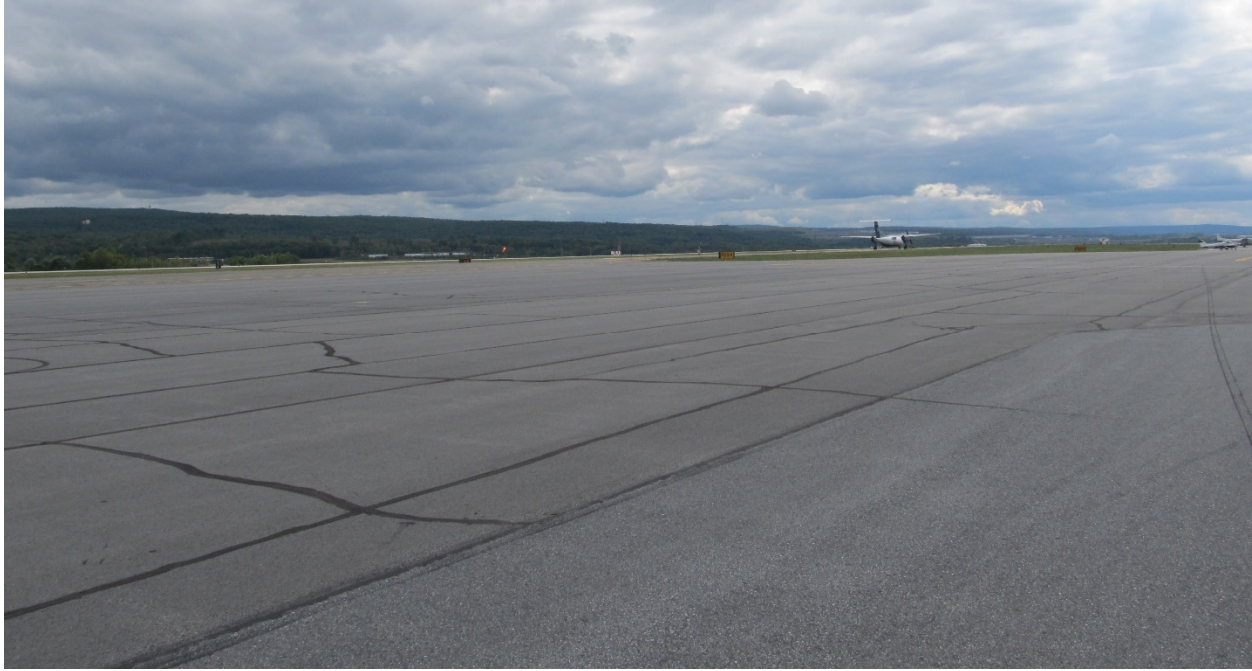
Overall ARFF/ Old Terminal Building Apron

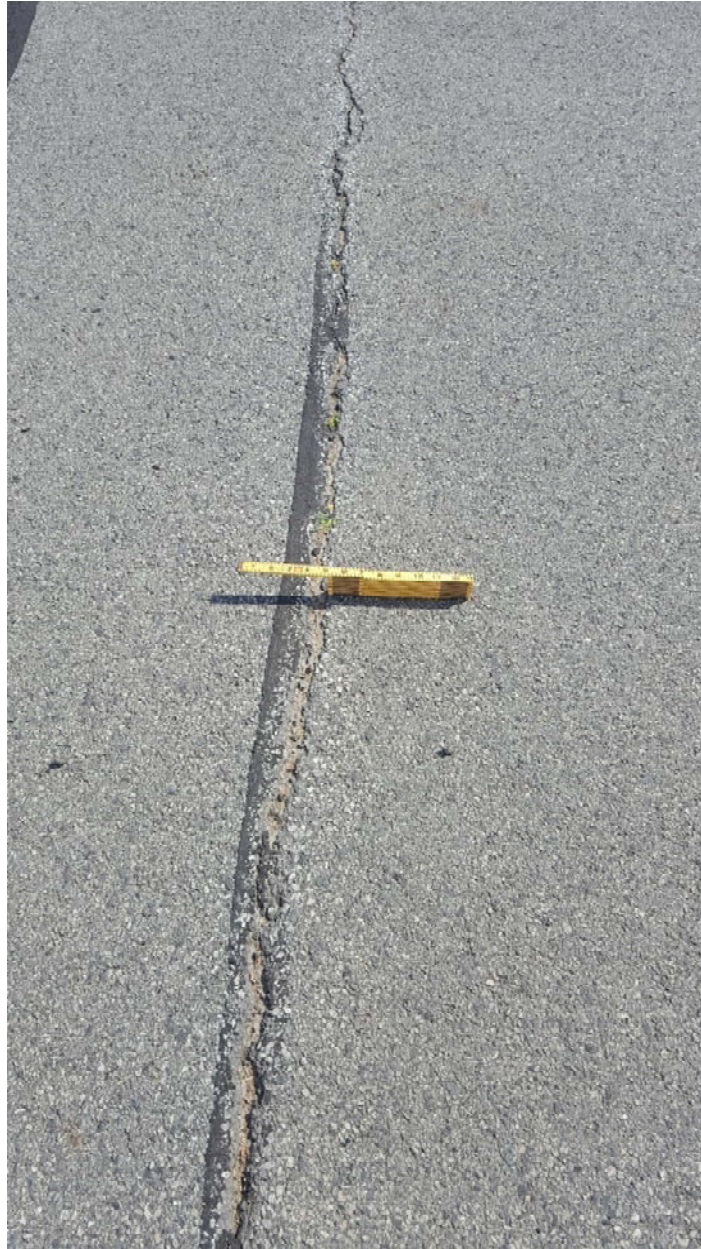
ARFF/ Old Terminal Building Apron High Longitudinal/Transverse Cracking

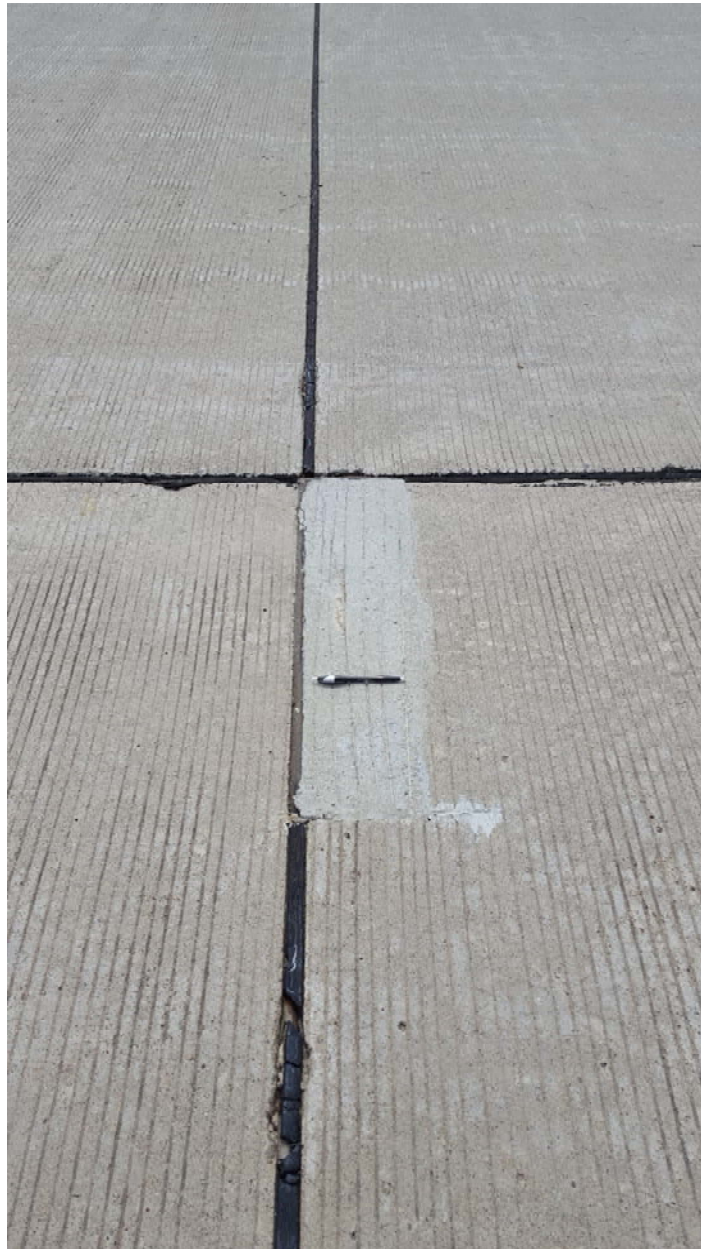
Cargo Apron Small Patch

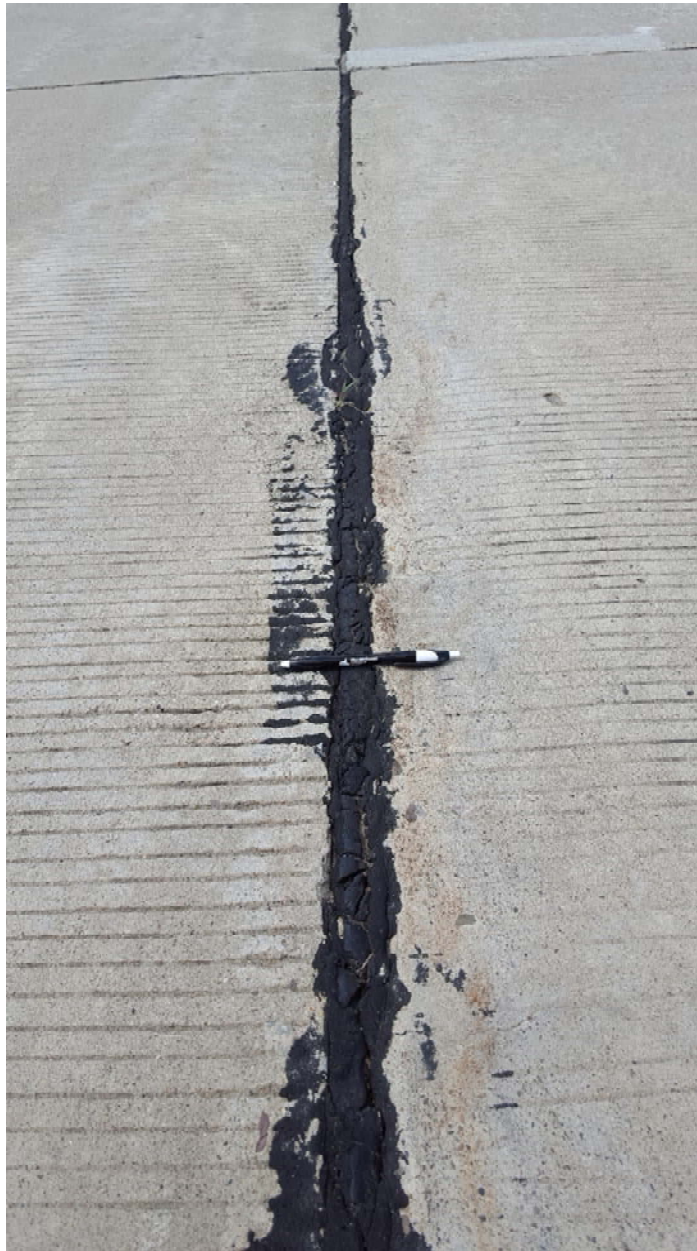
Cargo Apron High Joint Seal Damage

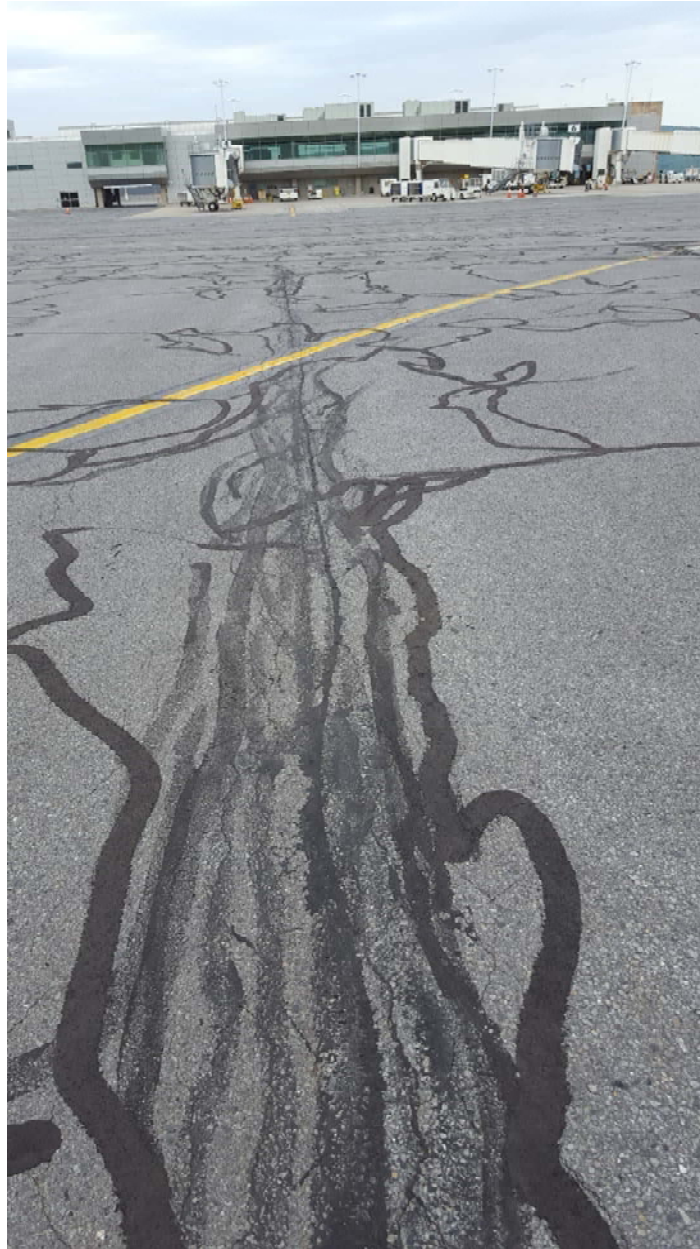
Commercial Apron Low Alligator Cracking

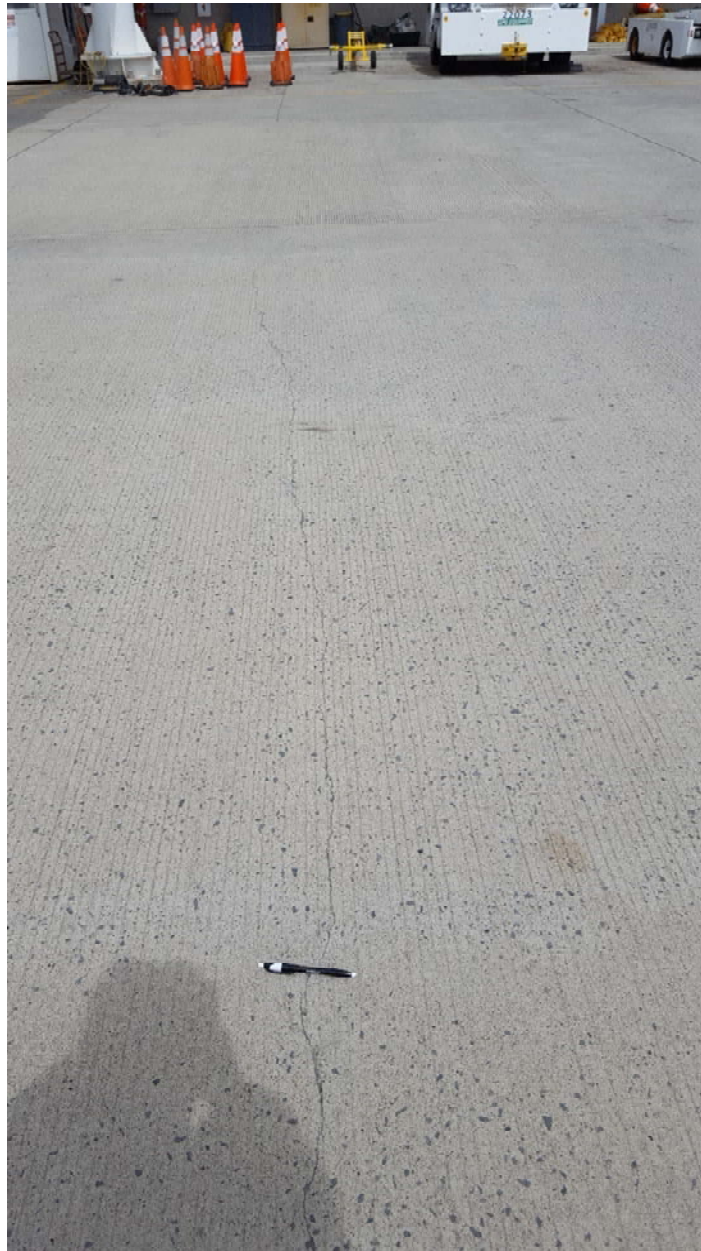
Commercial Apron Low Longitudinal Crack

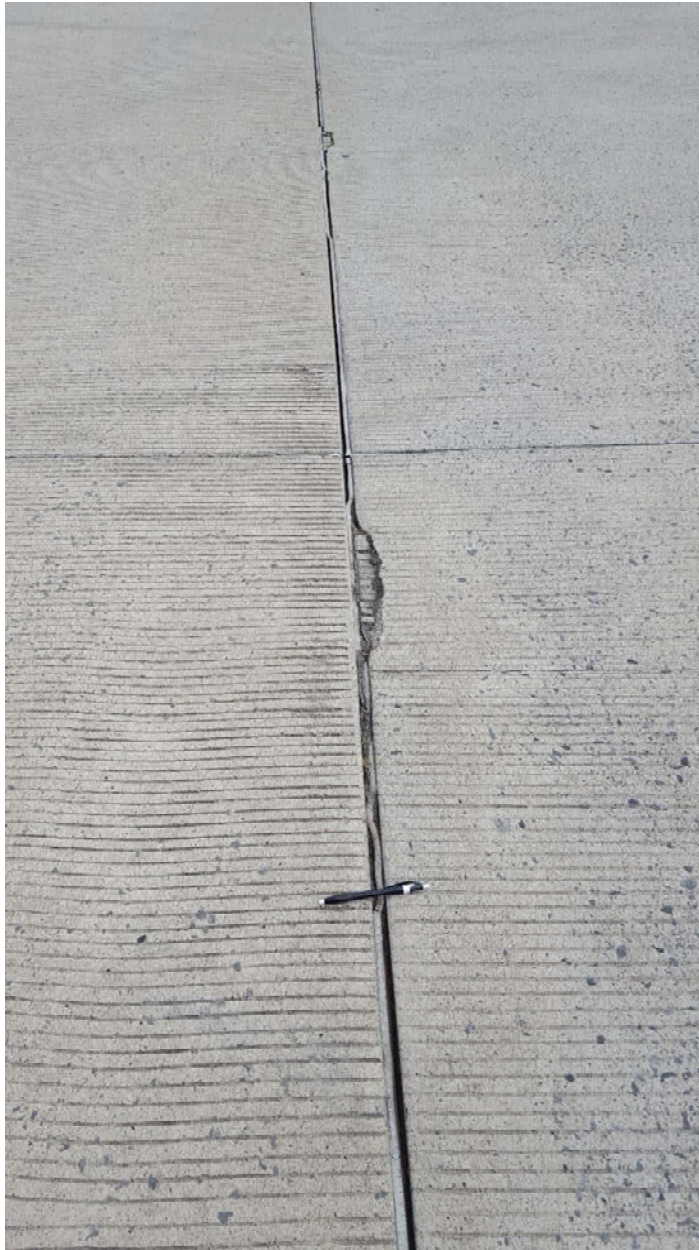
Commercial Apron Low Spalling

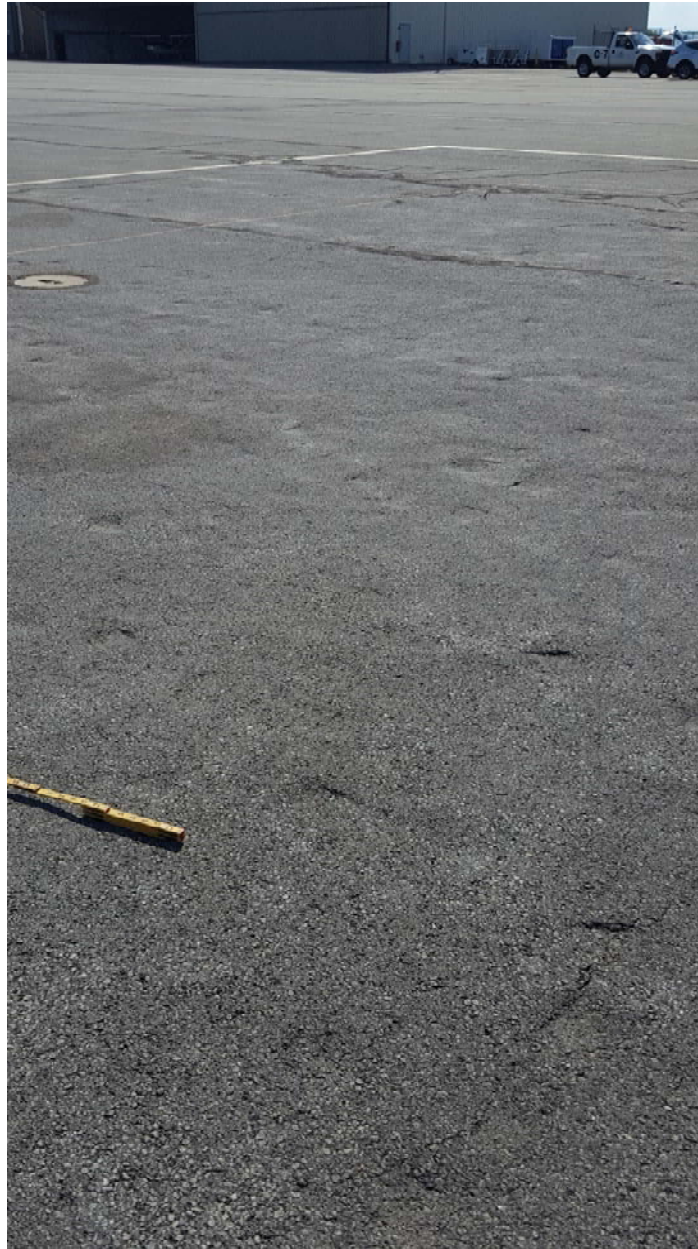
General Aviation Apron Medium Rutting

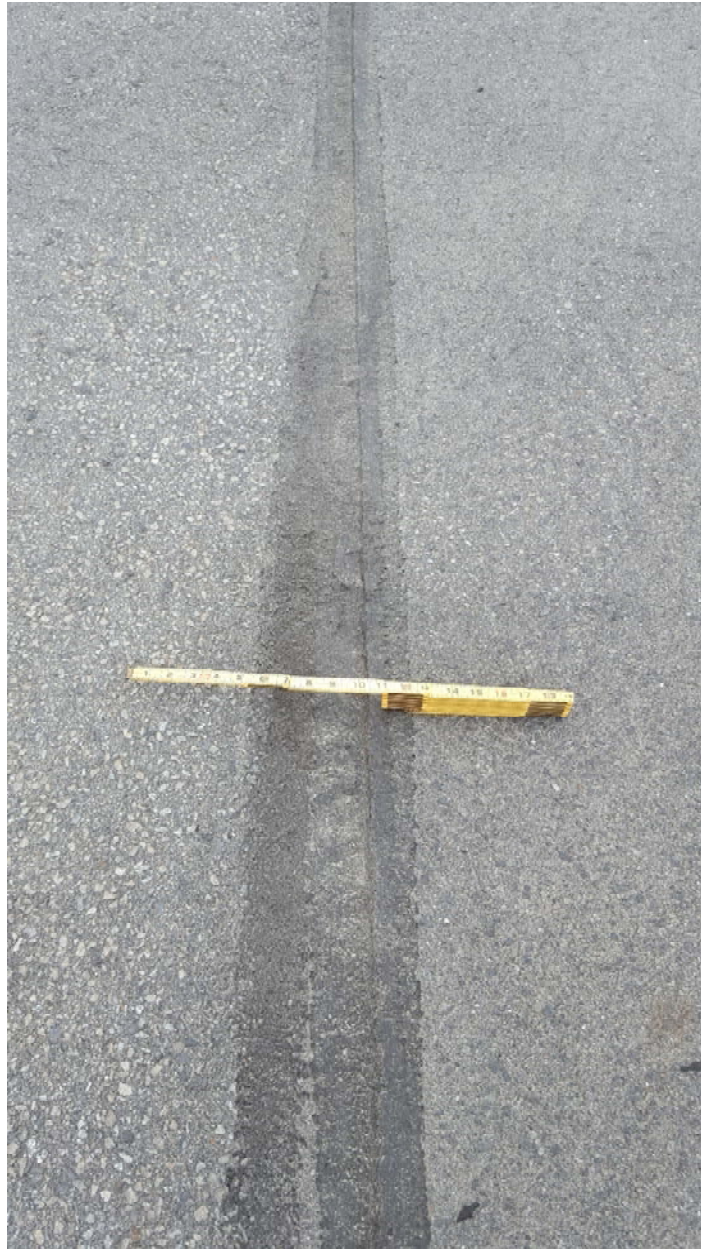
General Aviation Apron Low High Longitudinal/Transverse Cracking

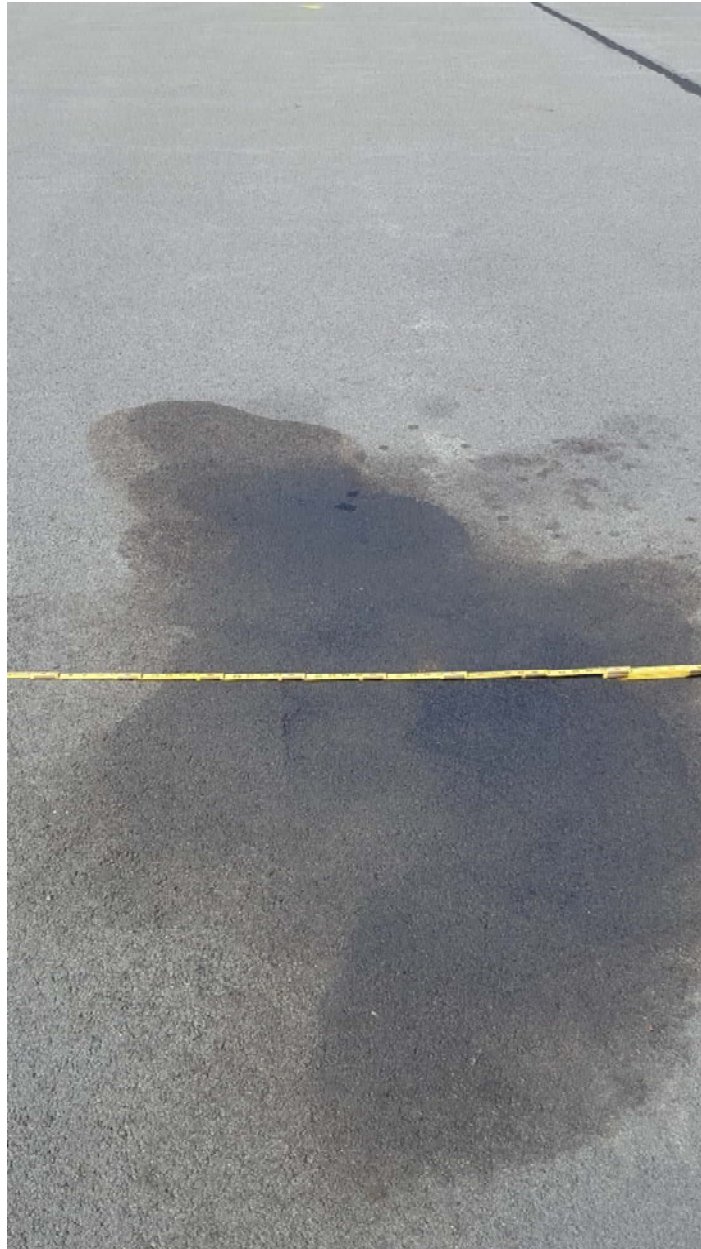
General Aviation Apron Oil Spill

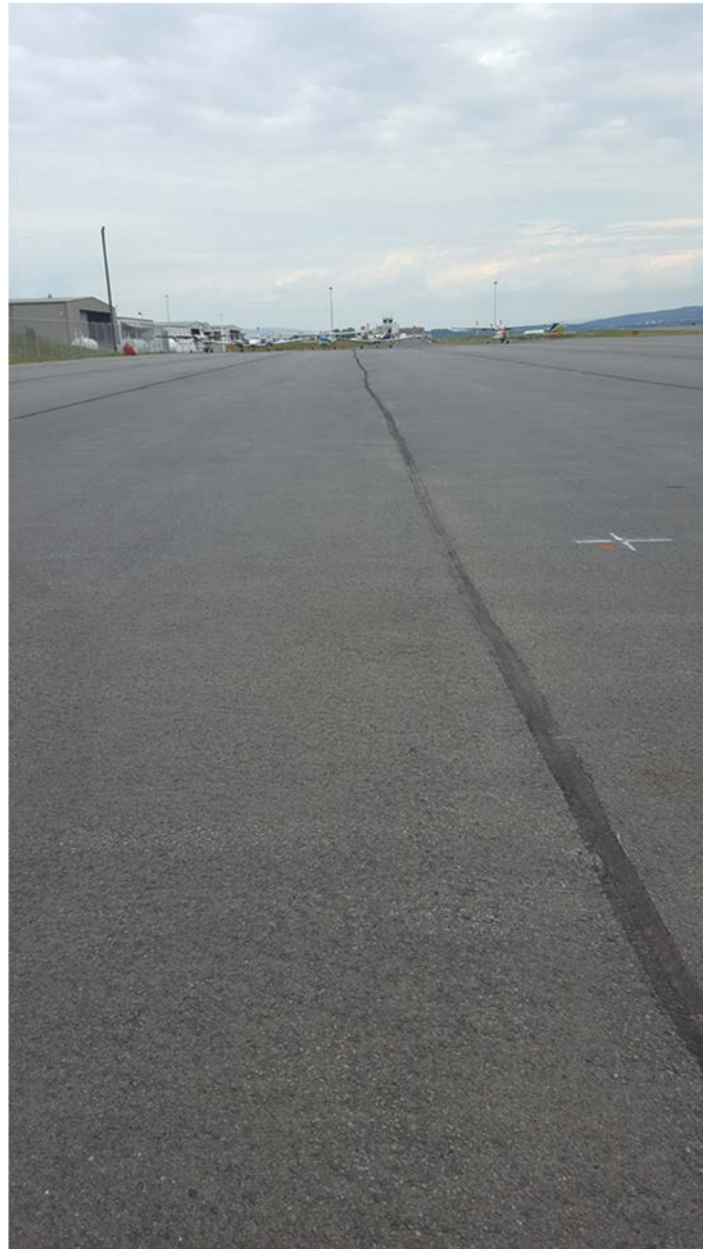
Overall South General Aviation Apron
